# **Canyon Creek Alluvial Fan Risk Assessment**

**Final Report  
September 2003**

Whatcom County Flood Control Zone District

KWL File No. 2039.001

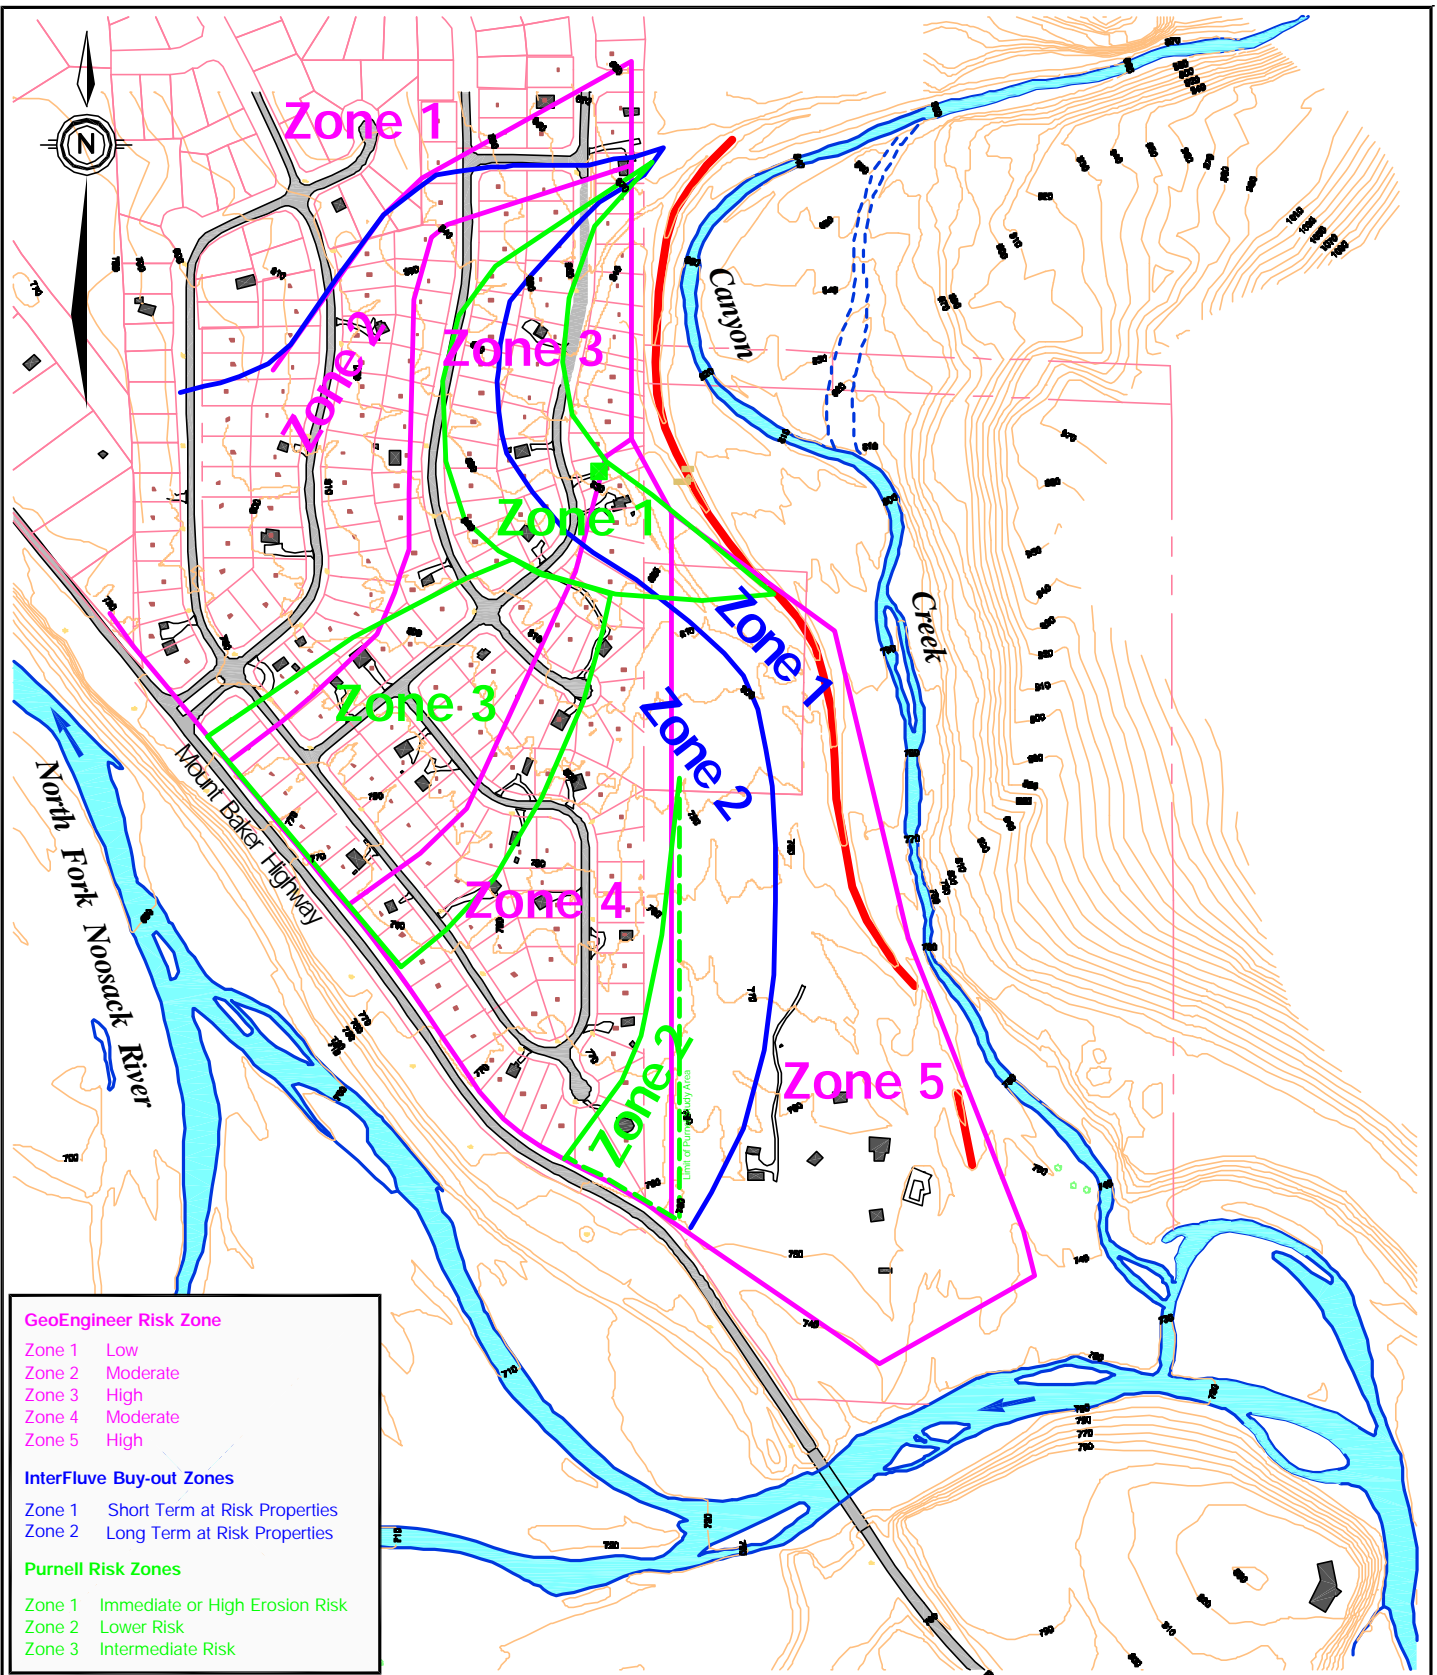
Previous Canyon Creek  
Fan Hazard Zones

Purnell and Associates identified three hazard zones on the fan where future erosion could occur (Figure 2-4). Each of the hazard zones was assigned a level of risk and are defined as follows:

*Hazard Zone 1* This zone was identified as the most likely area where future damage to the subdivision could occur due to ongoing erosion. The hazard area encompasses twice the cumulative erosion area of the 1989 and 1990 events. Zone 1 was defined as an area of immediate or high erosion risk.

*Hazard Zone 2* Zone 2 is located along the southeast portion of the subdivision and includes an intermittent stream that runs along high ground. The headwall of the intermittent stream was observed to erode to the north when flowing. In the event the headwall of the intermittent stream reached the main channel of Canyon Creek, a major shift of Canyon Creek to the west was thought to be possible. Zone 2 was identified as a low risk area, although significant alteration to the creek could increase the risk.

*Hazard Zone 3* The potential hazard of Zone 3 was delineated on the basis of a low point in the side of the bank where some overspillage reportedly flowed during the 1990 event. Purnell and Associates felt that significant overflows from Canyon Creek could occur if a debris dam formed in

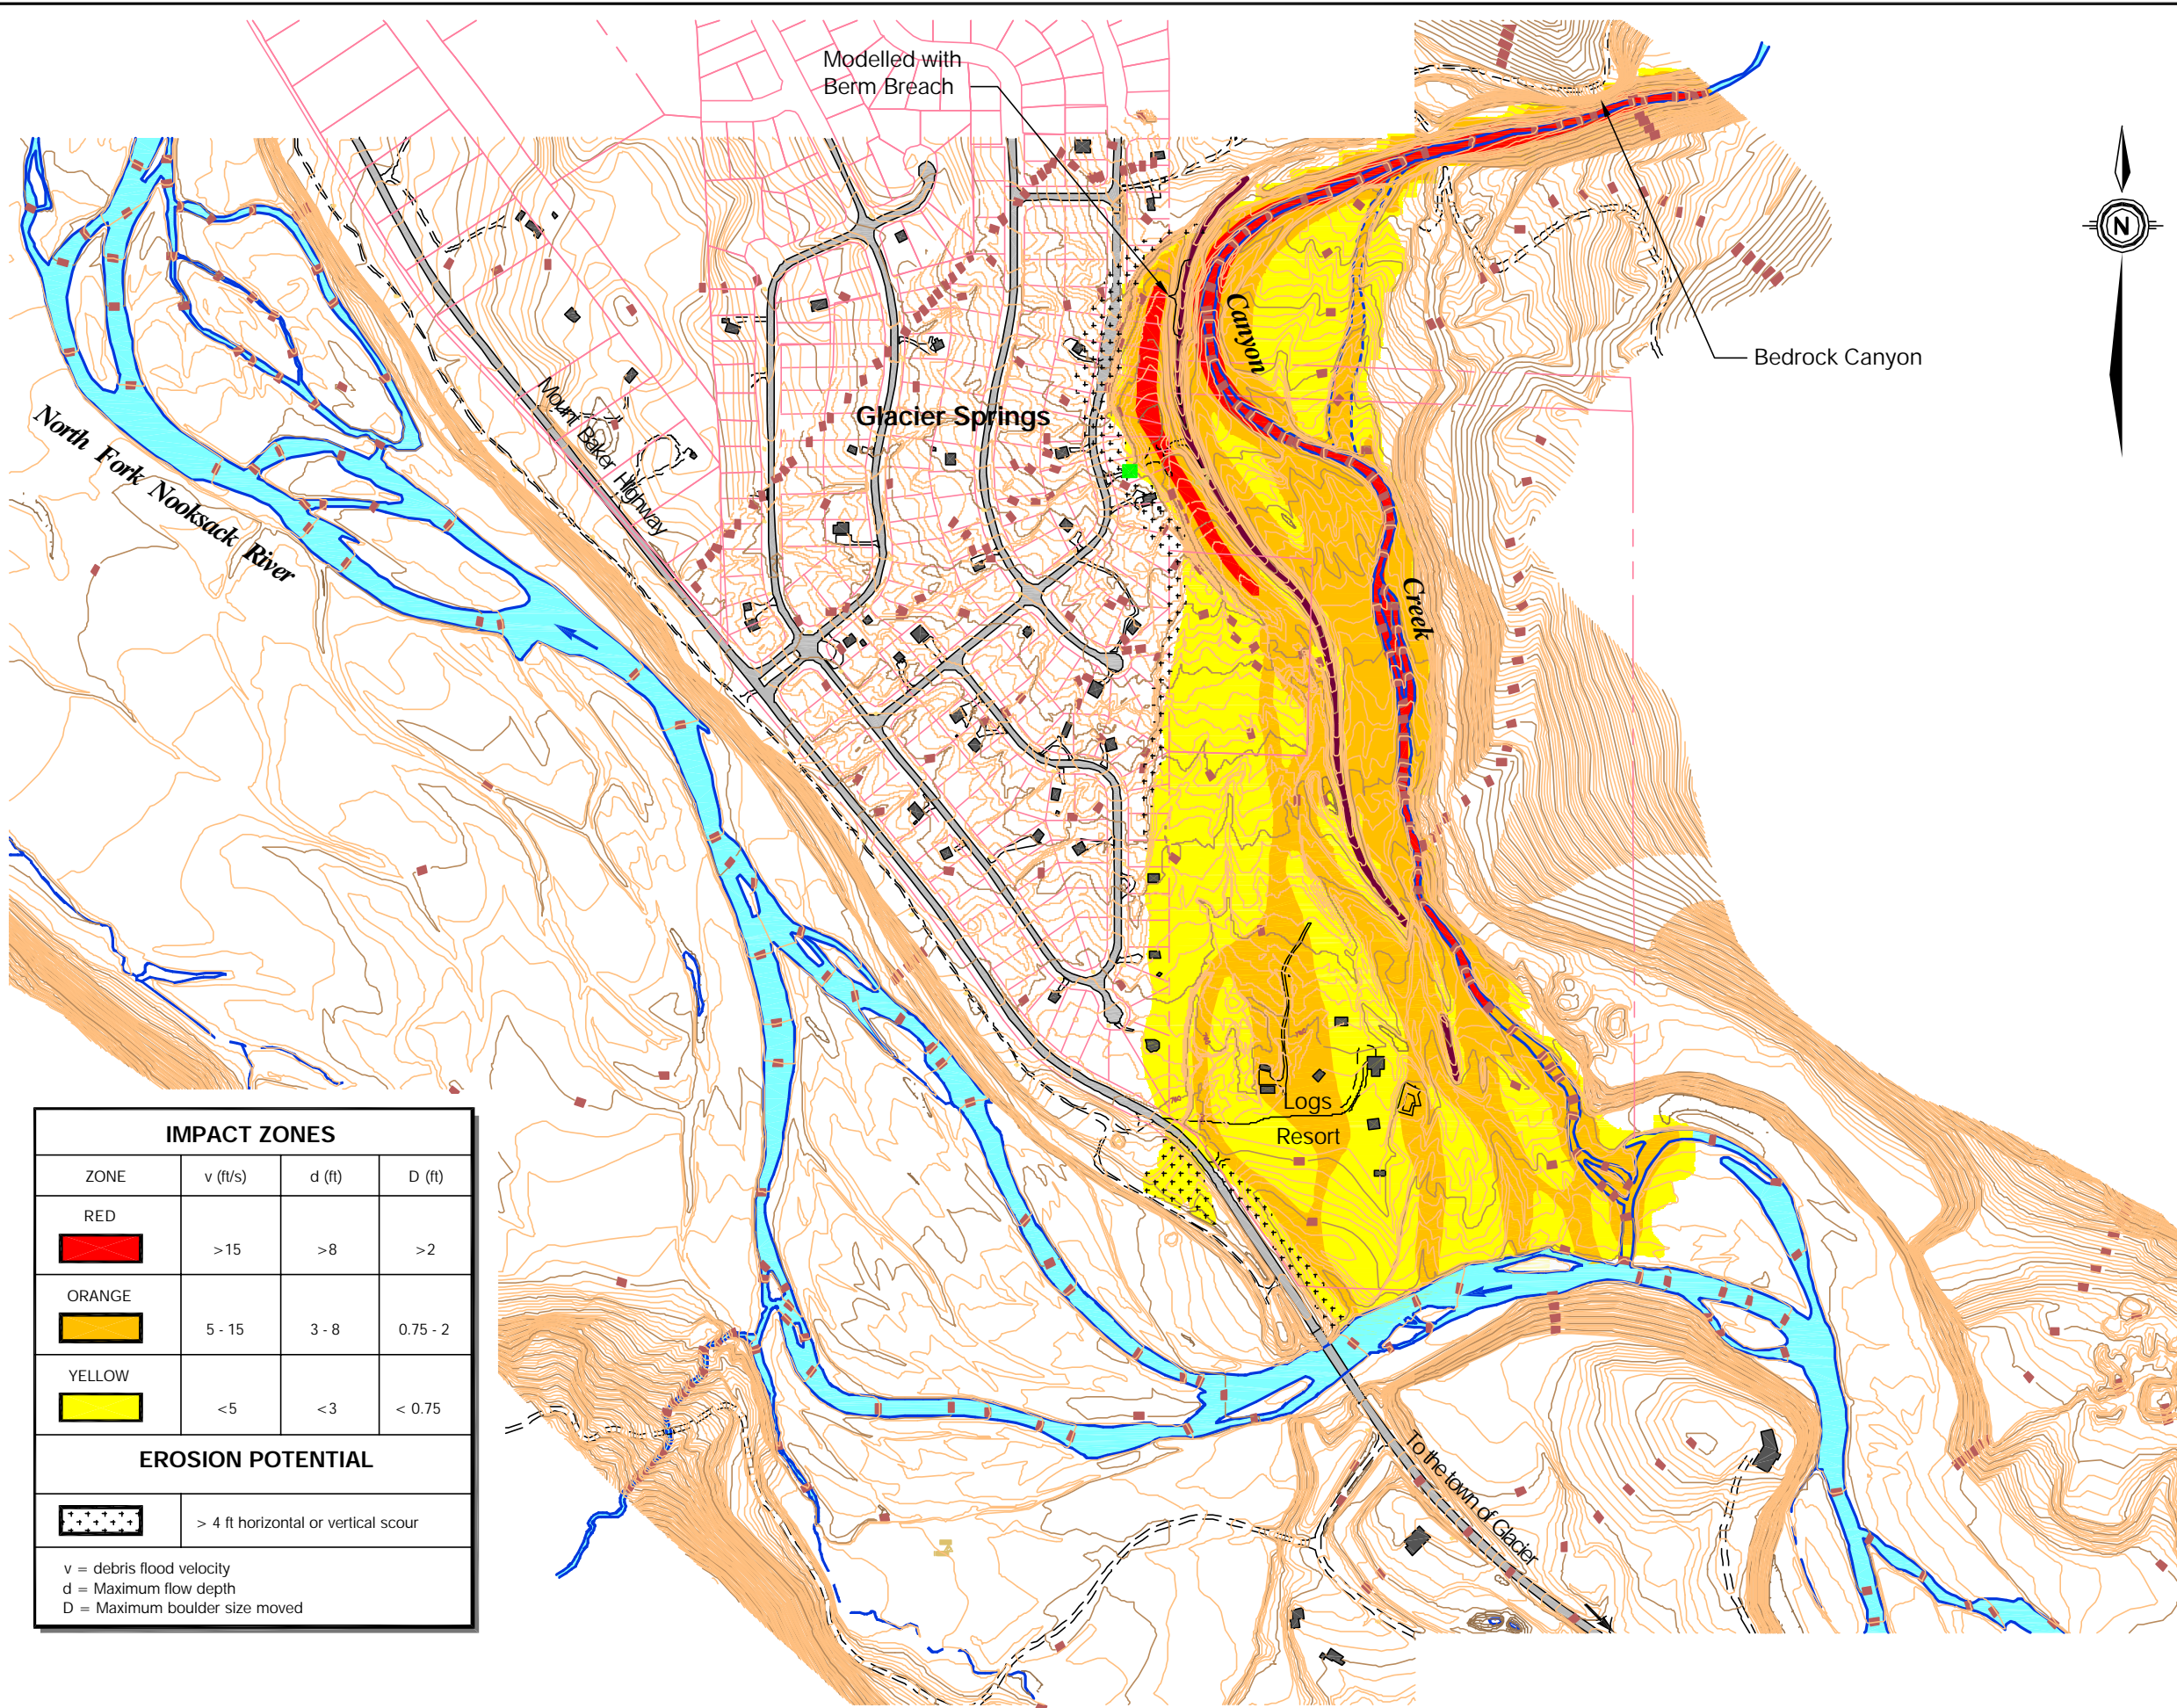
Canyon Creek  
Debris Flood  
Modelling Results  
for Design Event  
Figure 3-1

Debris flood runout on the Canyon Creek fan was modelled with FLO-2D software in order to estimate the flow depth and velocity on the fan for the design event. The model scenarios included existing conditions, berm removal, and a breach of the existing berm. The deposition of the design event was illustrated in map form (Figure 3-1). This map was used as a basis for defining three hazard zones on the fan (Figure 3-2).

The above table illustrates that under existing conditions, the design event (a medium probability debris flood) at Canyon Creek poses a high risk (bold row). The implication is that events having return periods of 100 to 500 years (40% to 10% chance in 50 years) will cause damage to multiple houses by debris impact or erosion.
