# **Canyon Creek Alluvial Fan Risk Assessment**

**Final Report  
September 2003**

Whatcom County Flood Control Zone District

KWL File No. 2039.001

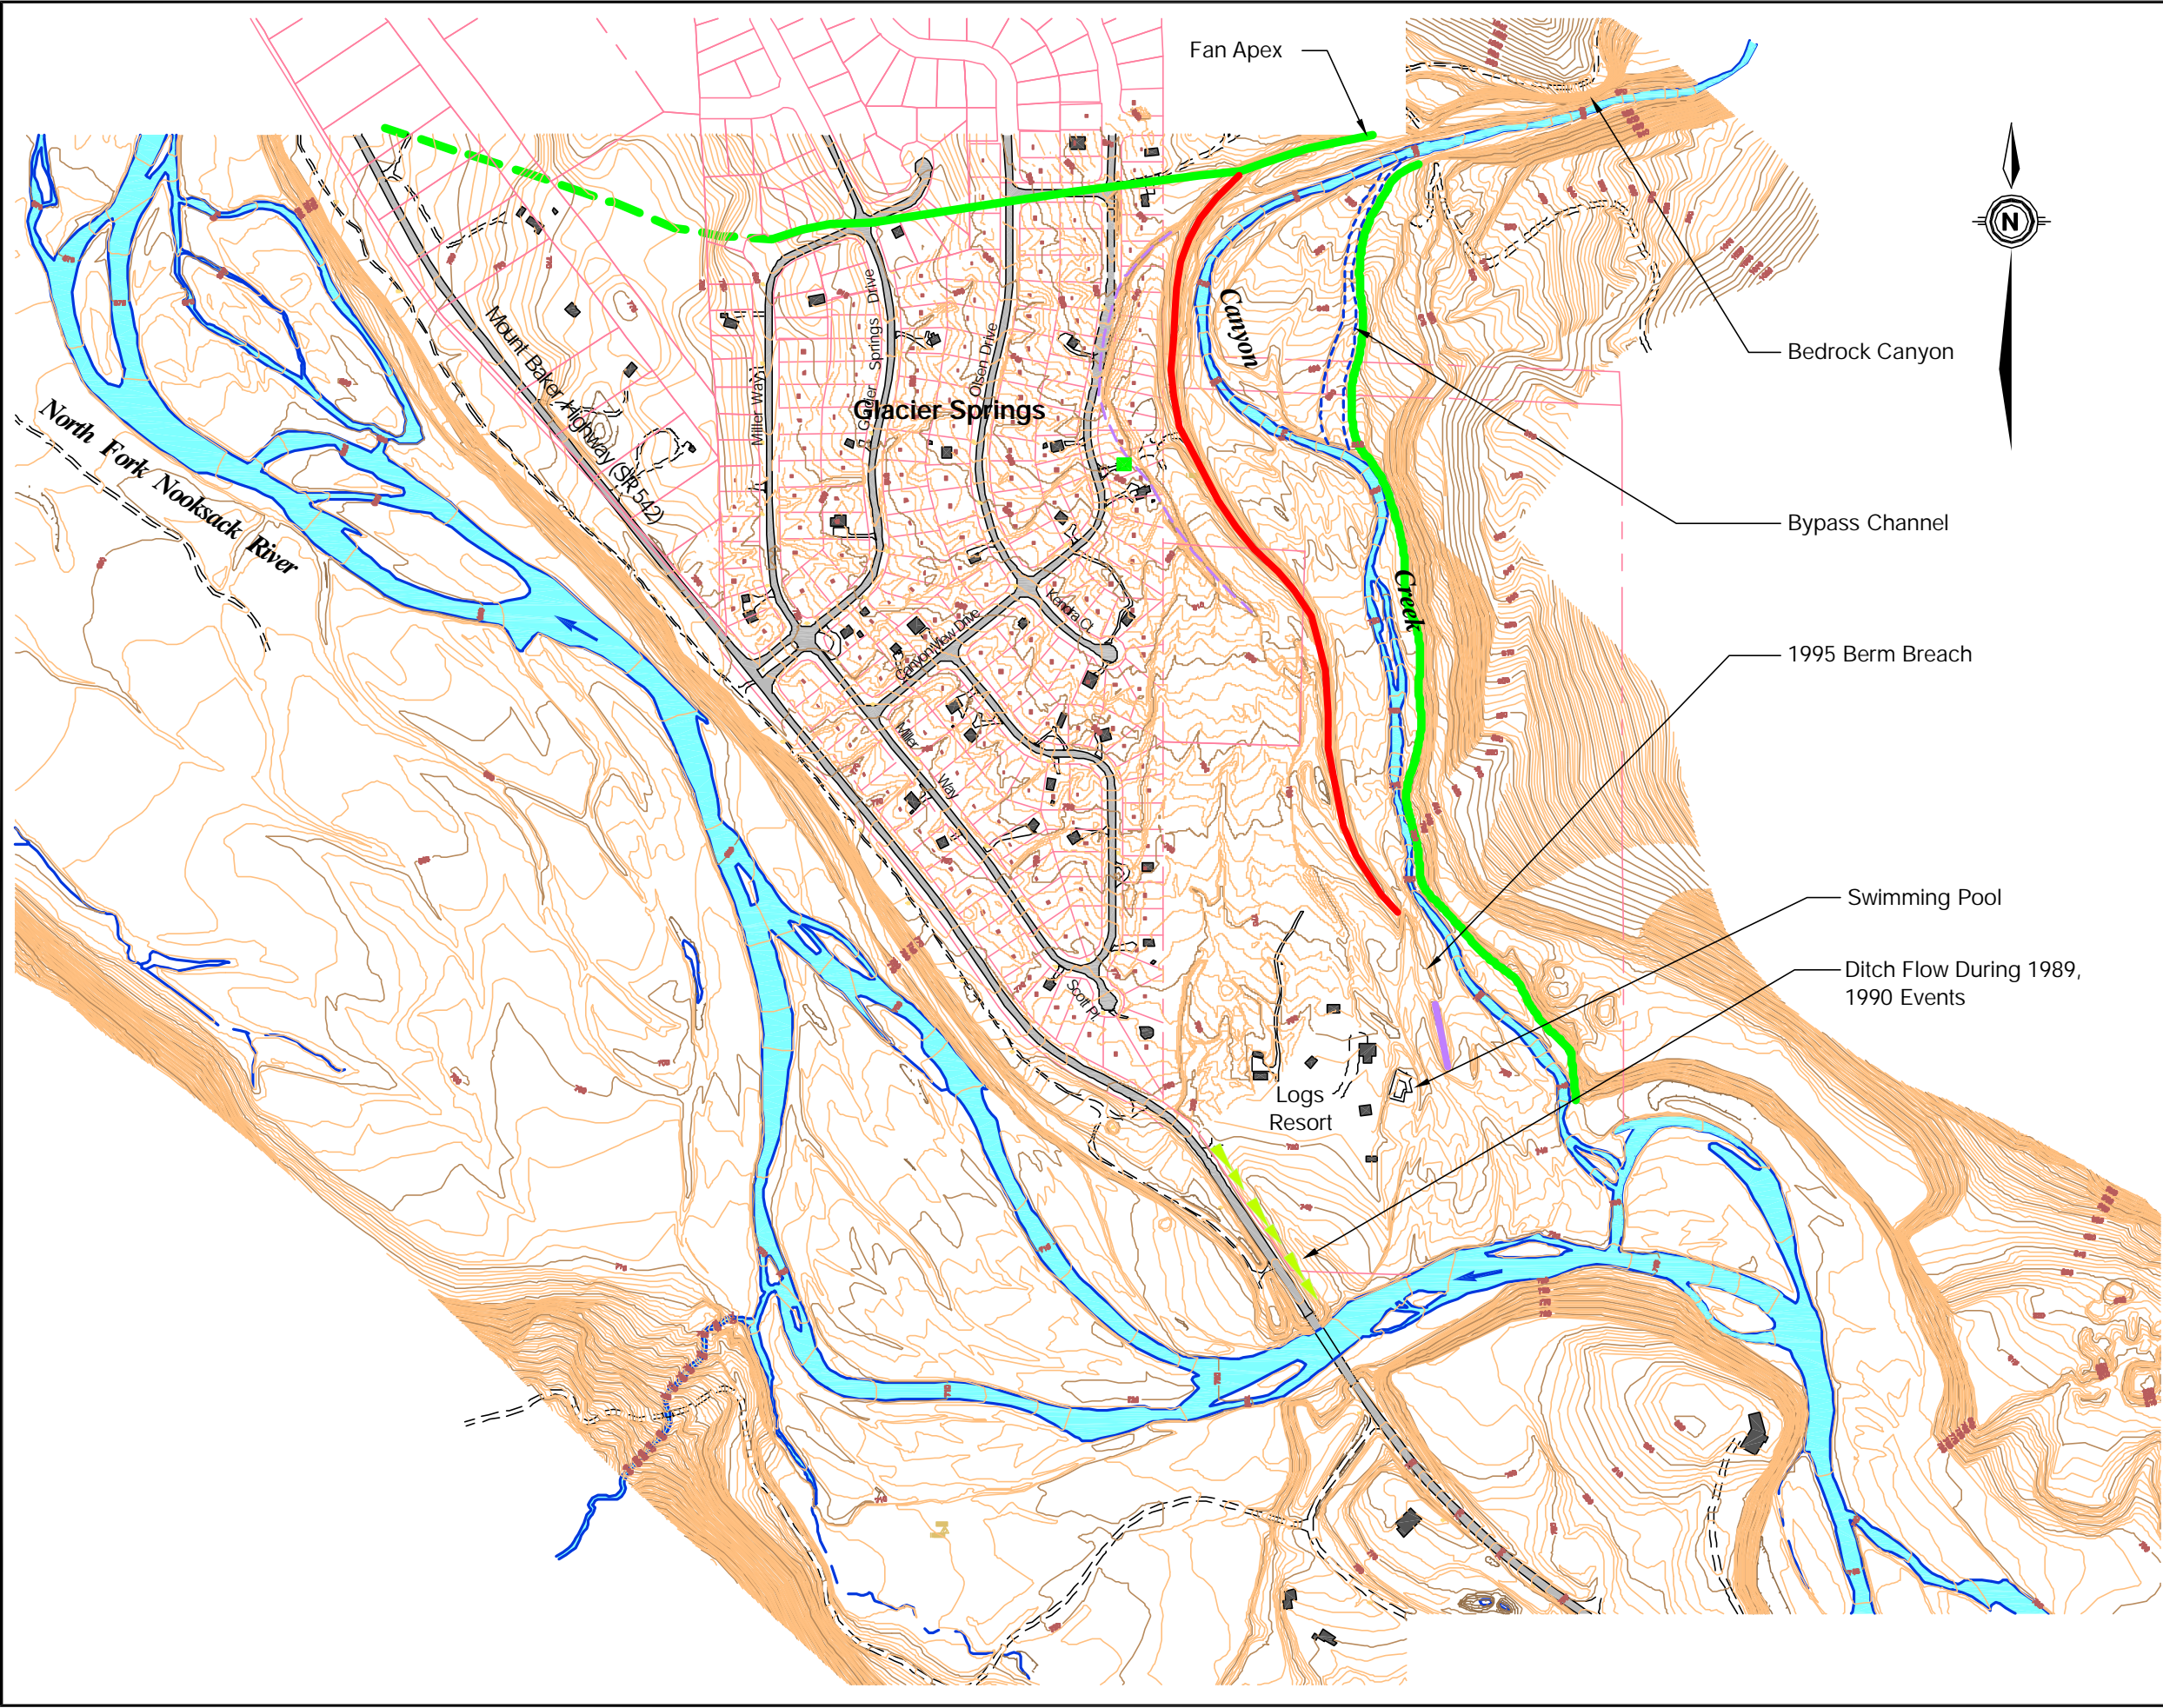
Figure 1-3

Below the riprapped section, the berm was extended downstream a further 450 ft (137 m) to provide additional protection to the Logs Resort. However, this section of the berm was not armoured (Figure 1-3). The proposed berm on the left bank in the lower reaches was eliminated as a contract item because it was felt that the existing natural bank provided adequate flow deflection. Elimination of the left berm also provided additional area for sediment deposition during peak flow events.
